# REFORMER TUBES & COMPONENTS

Comprehensive services for testing reformer tubes.

# Reformer Tube Testing

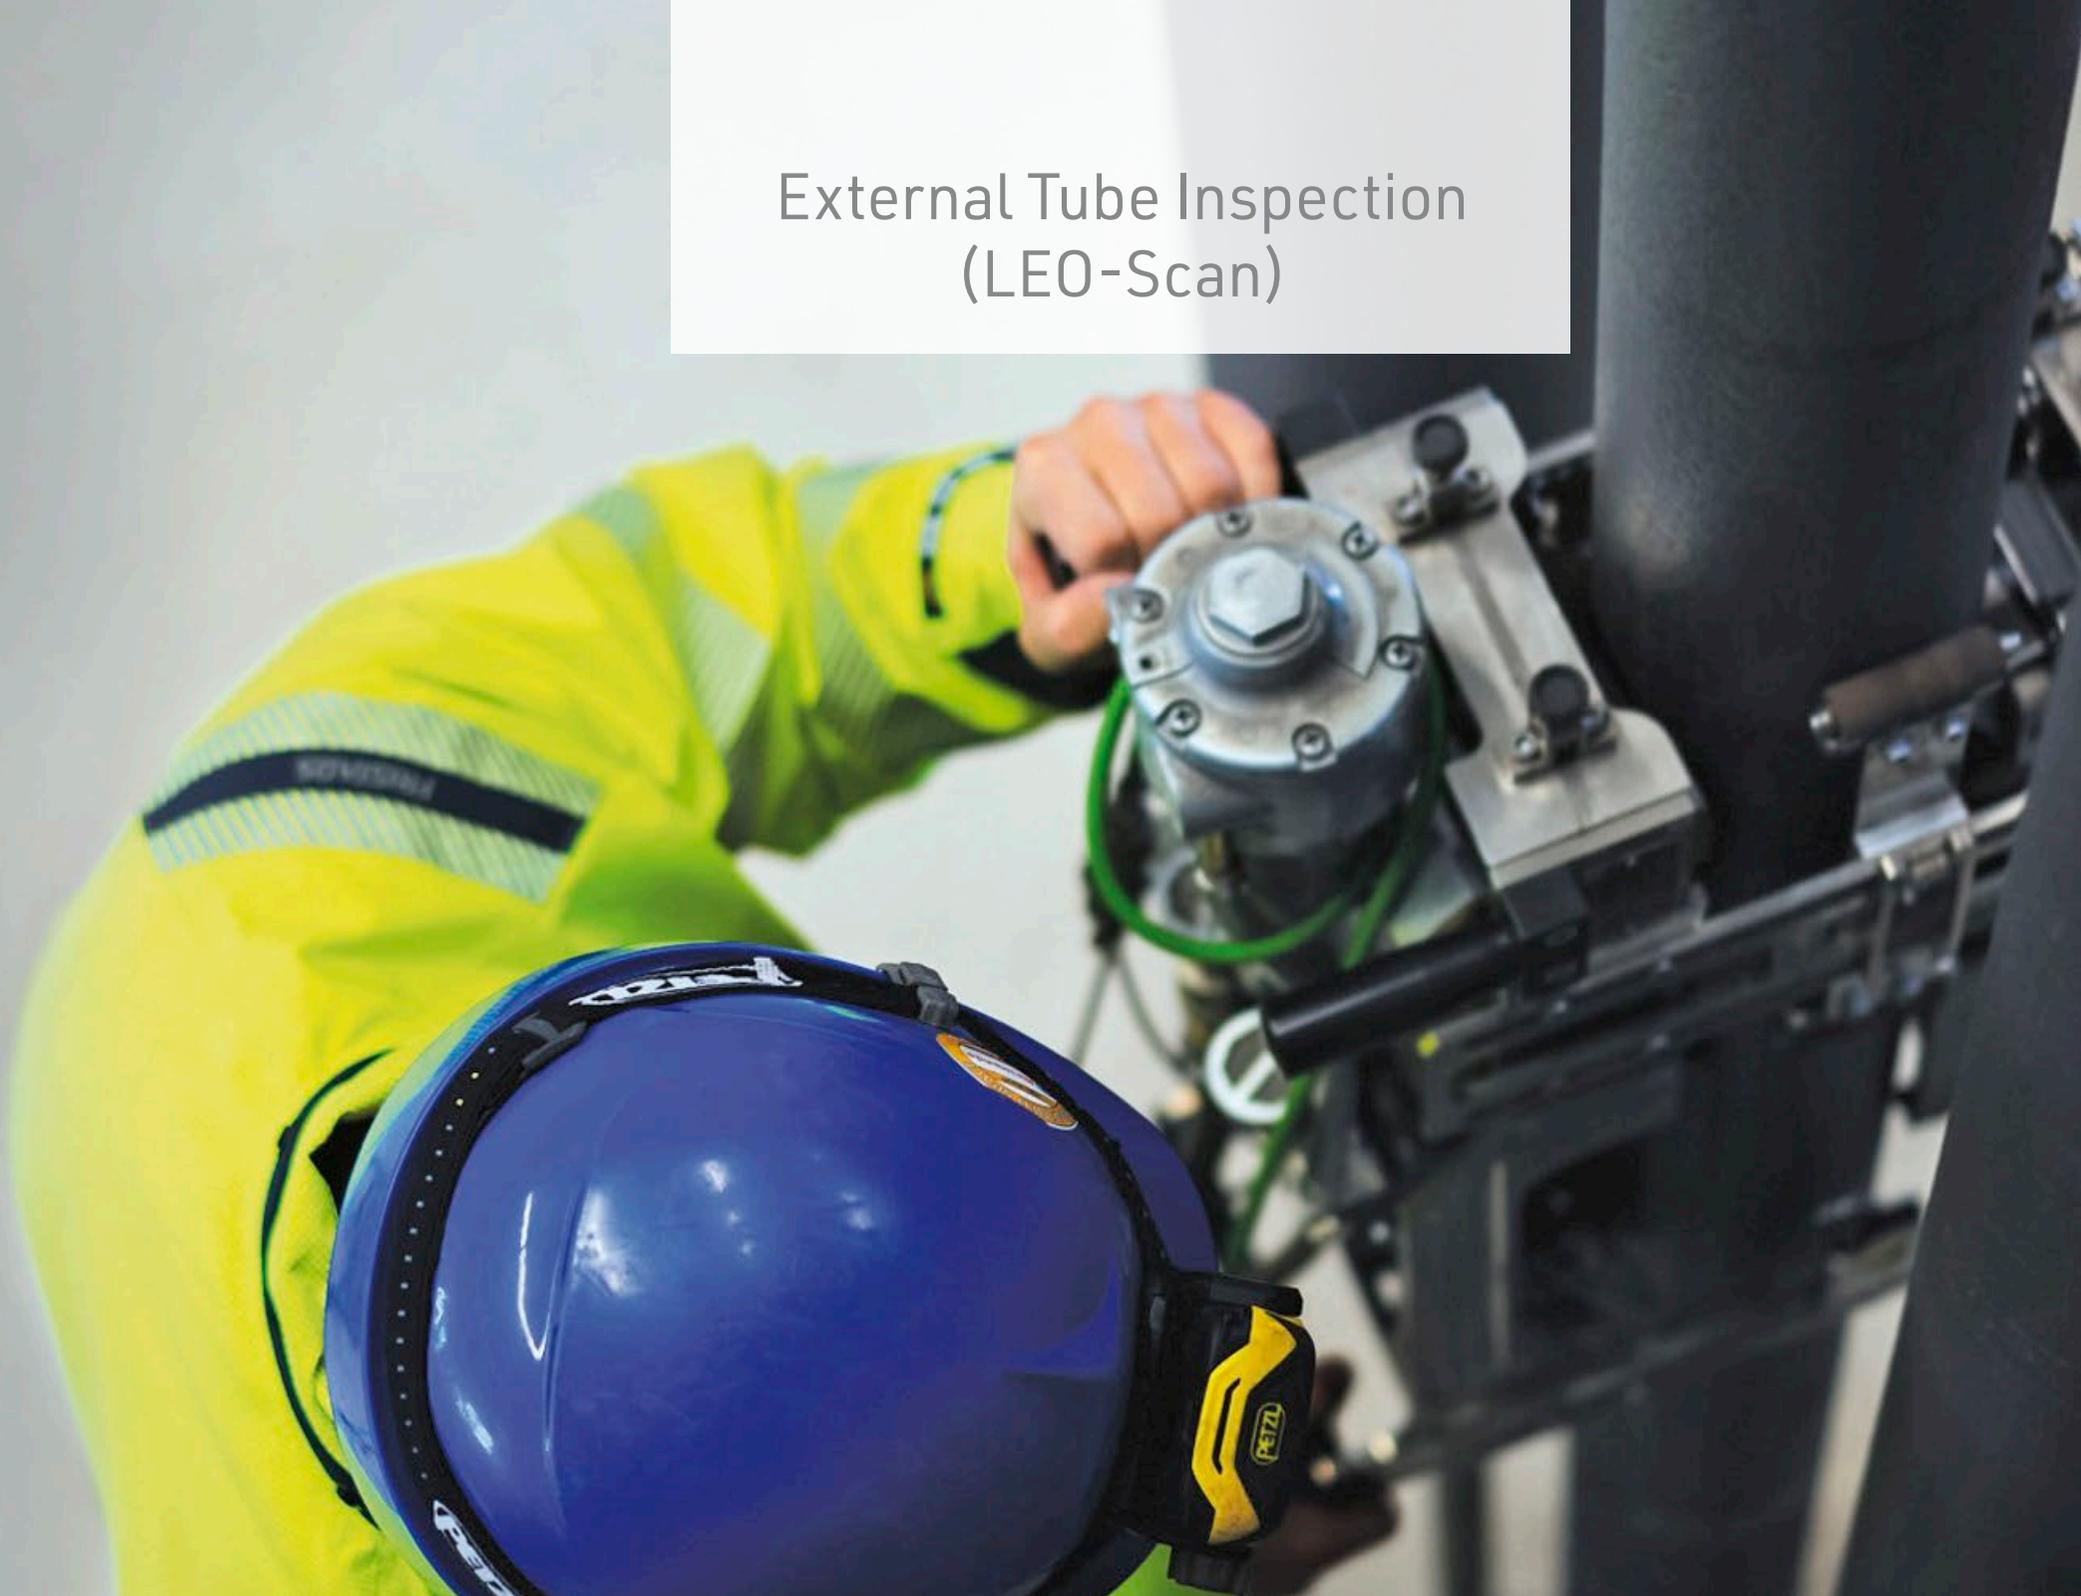
## External Tube Inspection (LEO-Scan)

For the purpose of inspecting centrifugally cast reformer catalyst tubes used in steam methane reformers, FOERSTER has developed and built the proprietary "LEO-Scan" system, an inspection carried out from the outside of the tubes, using the Eddy current and Laser technique.

The complete LEO-Scan system is mounted on a unique tube crawler. The special construction of the crawler transports the sensors from the furnace floor – depending on reformer design – all the way up to the roof. This includes the areas below the top of any flue gas collection tunnels, if present. The probes and lasers are mounted near the bottom of the crawler, allowing readings to be taken in the most critical areas of the typical down-flow reformer, since this is considered the hottest portion of the tube. The device is also intended to test reformers with tube-to-tube clearances as narrow as 20 mm (0.79 in). This allows the inspection of furnace designs with very tight clearances from the OD. Other crawler and probe configurations are also available to test up-flow reformers. No cleaning of the tubes is required.

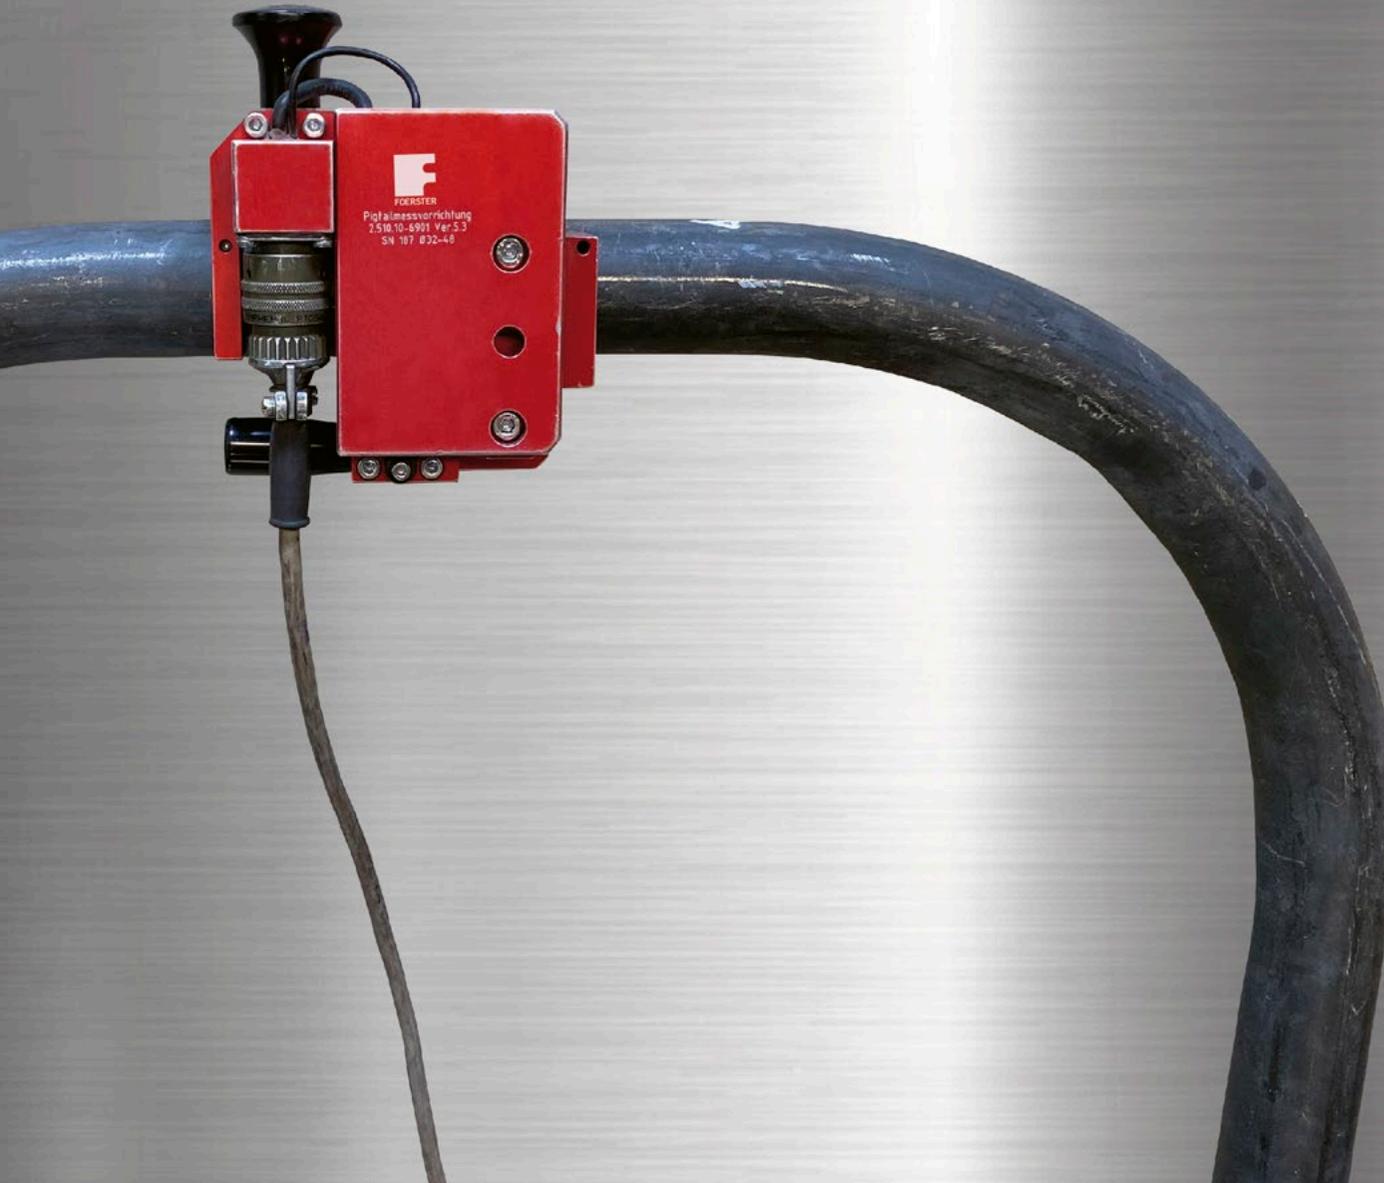
# Monitoring the Condition of Outlet Pigtails

Wrought outlet pigtails are critical components that need rigorous inspection due to their location and intended function. For the identification and determination of creep, we have developed a unique device for measuring pigtails diametrically from the tube outlet to the manifold.

The measurements are taken on two axes; this configuration enables evaluation of diametrical growth of both the straight pigtail sections and the bends, taking into account the inherent (and normal) differences in diameter due to the bending process. Compared to manual gauge testing, this new system is very fast, reliable and repeatable. It also provides an accurate diameter profile over the complete length of the pigtail, resulting in an assessment of creep in digital form that can be used for future evaluations.
