REFORMER TUBES & COMPONENTS

Comprehensive services for testing reformer tubes.

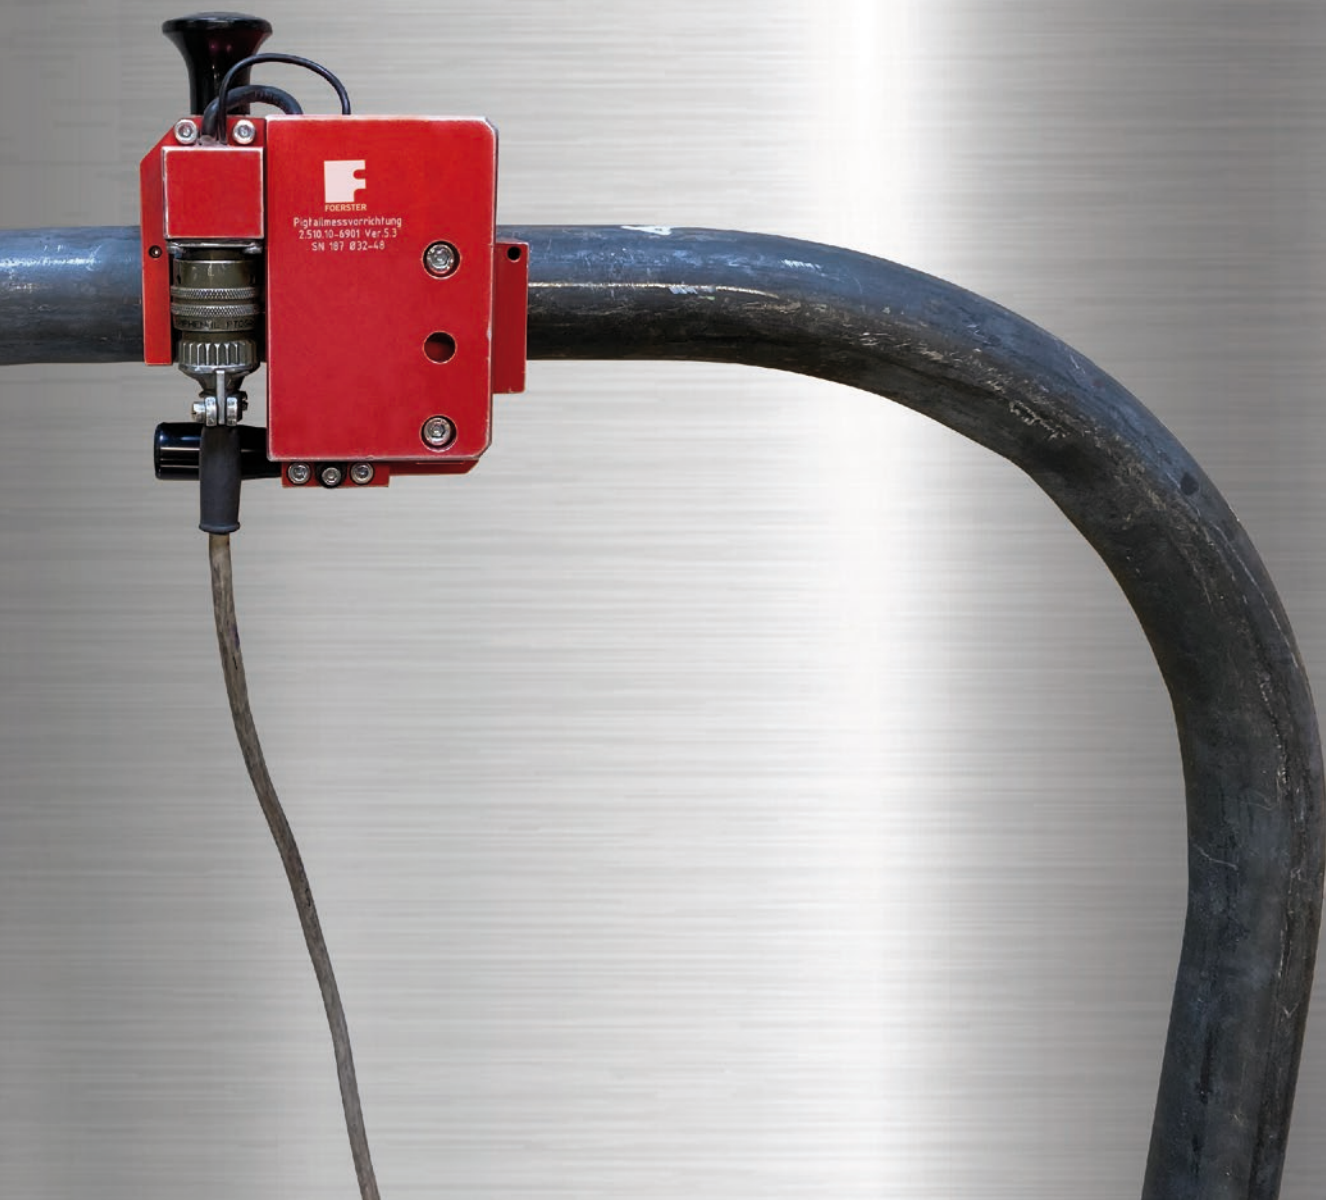
Wrought outlet pigtails are critical components that need rigorous inspection due to their location and intended function. For the identification and determination of creep, we have developed a unique device for measuring pigtails diametrically from the tube outlet to the manifold.

The measurements are taken on two axes; this configuration enables evaluation of diametrical growth of both the straight pigtail sections and the bends, taking into account the inherent (and normal) differences in diameter due to the bending process. Compared to manual gauge testing, this new system is very fast, reliable and repeatable. It also provides an accurate diameter profile over the complete length of the pigtail, resulting in an assessment of creep in digital form that can be used for future evaluations.
